The Kintaikyo Wooden Bridge

— spanning as evidence of relationship
between human being and nature —

Kintaikyo World Heritage Promotion Office
City of Iwakuni
All rights reserved

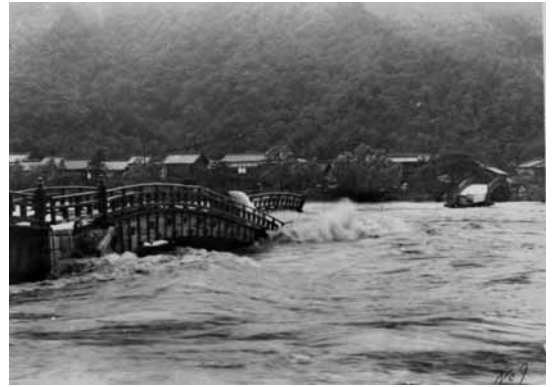
Photo 3: An arch being washed away following the collapse of the fourth pier, due to the erosion of its stone footing

The Kintaikyo Bridge was washed away on September 14, 1950, when the River's flow volume increased to 3,700 m³ /s at the point of the Bridge. This flow volume exceeded the design high water discharge of 2,470 m³ /s. Over the preceding two days, average precipitation in the catchment area had been 328.8 mm (Photo 3).

During the dry season (November to April), flow volume decreases as shown in Photo 4. Once flooding occurs, however, the water level rises as shown in Photo 3.

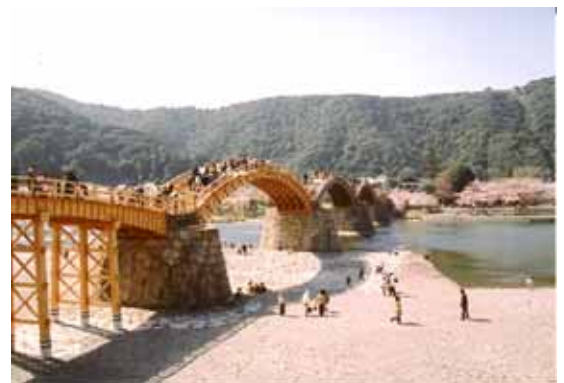
Photo 4: The Nishiki River during dry season

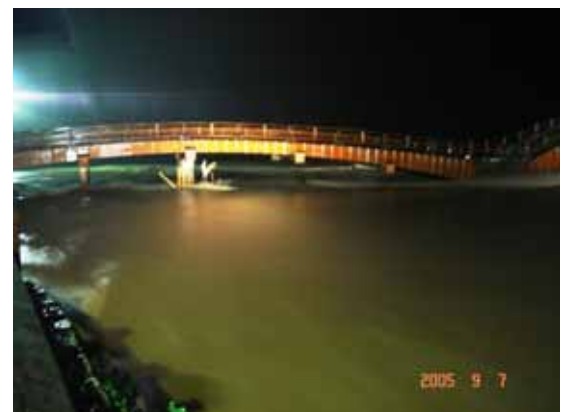
Photo 6: The flood of September 2005

In 2005, Typhoon 14, which was formed between the night of September 6 and the dawn of September 7, 2005, brought heavy rainfall (maximum precipitation: 59 mm/hour) over the upper reach of the Nishiki River. The daily precipitation reached 472 mm, the heaviest rainfall in recorded history in Japan. At the observing station situated 600 meters downstream from the Kintaikyo Bridge, the water level reached 7.32 meters at 1:00 a.m. on September 7, as compared to the danger level of 6.4 meters. The flow volume at that time was approximately 5,400 m³ /s (Photo 6), which was much greater than the level recorded when the Bridge was carried away in 1950. The heavy rainfall indicated that the three dams were insufficient to control flooding of the Nishiki River, thereby demonstrating the strategic importance of the Bridge design, including its spans and height of piers.

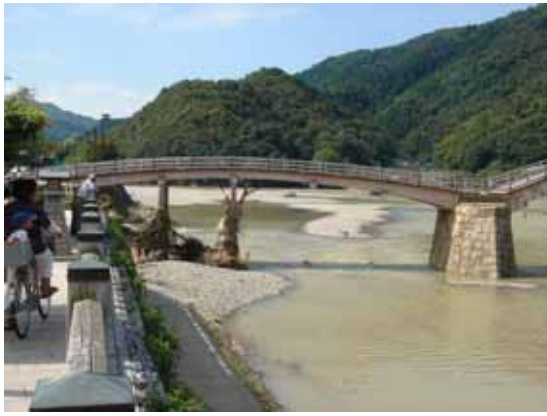
Photo 7: The first span after losing two piers in the flood of 2005

The typhoon inflicted extensive damage on Kintaikyo Bridge. The drift from upper reaches destroyed two piers of the first span (Photo 7), causing damage to the fifth span as well (Photo 8). After the typhoon, approximately 40 million yen was needed to restore the Bridge. Damage inflicted on all of Iwakuni City amounted to approximately 14.8 billion yen.

Despite the loss of the two piers from the first span, its superstructure remained intact. The superstructure was protected by the design of a special tenon called *hozo* (projection left by cutting away the wood around it for insertion into another member to make a joint) (Photo 9). Unlike typical tenons, which are designed to join members firmly, the *hozo* used in the Bridge had been tapered to allow members disjoint easily, so that substructural damage would not impact the superstructure. In other words, the *hozo* was designed to function in a way similar to a fuse in an electric circuit. This unique *hozo* design was developed over the long history of the Bridge, which experienced frequent storms and floods. Although the great flood of 2005 occurred 55 years after the similarly great flood of 1950, slightly less serious floods strike every few years. The Kintaikyo would have been carried away more frequently, had its central portion been a girder bridge equipped with many piers.

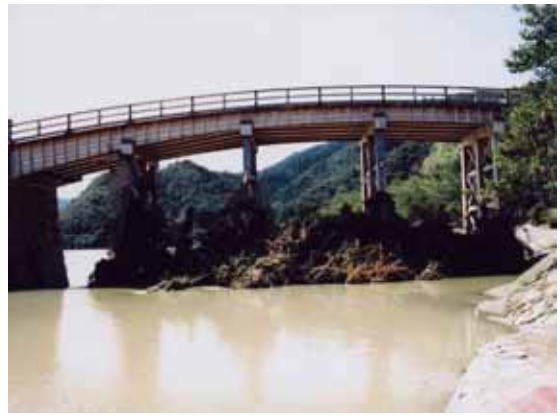
Photo 8: Drift that blocked the water flow under the fifth span

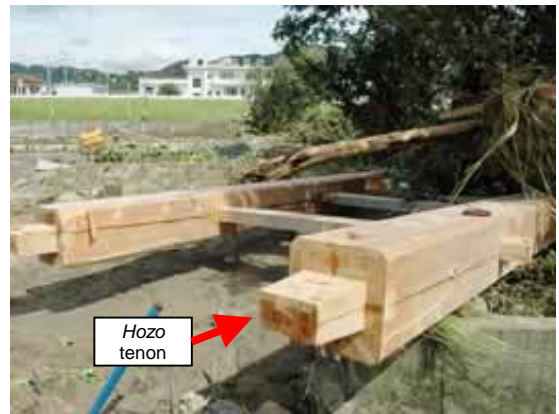
Photo 9: Tapered *hozo* tenon, a design to enhance the ease of disjoining

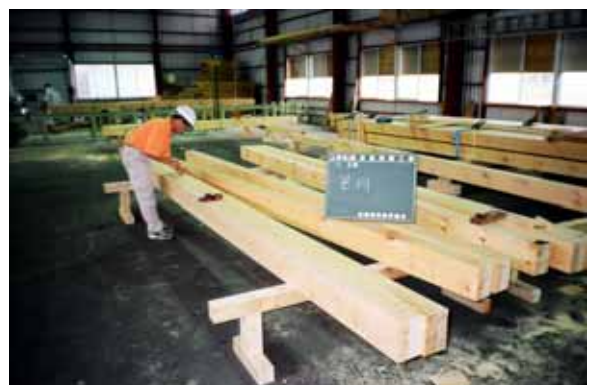
Photo 10: Marking on timbers

Since the Edo Period, carpenters have passed down verbally the secrets of their technology, or aspects that are difficult to express either in text or drawing. Among such secrets is the method of learning from wood the nature inherent in each respective wood type. Each timber has a different and unique nature, which can be learned only by viewing and touching the timber, and using all five senses. Without knowing the nature of each timber, carpenters cannot use it for the appropriate purpose (Photo 10).

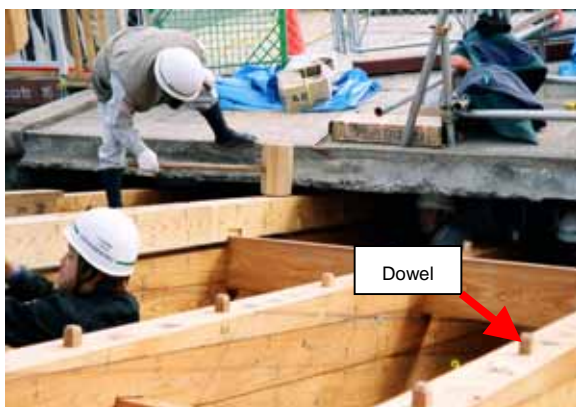
Photo 11: Installed Dowels

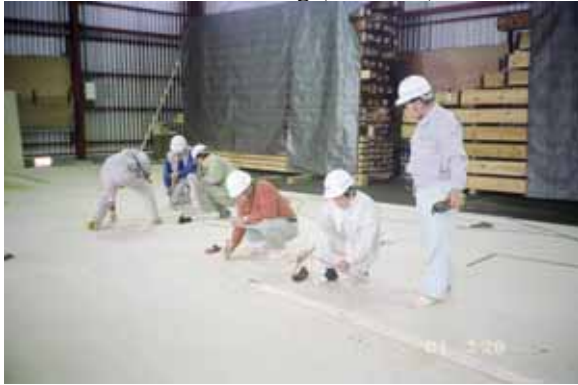
Photo 13: Girder Members Are Drawn

Prior to timber-working, a full-scale drawing is created (Photo 13) based on the actual arch dimensions; all girder members and other members are drawn on it. The templates for respective members are then produced from the full-scale drawing (Photo 15).

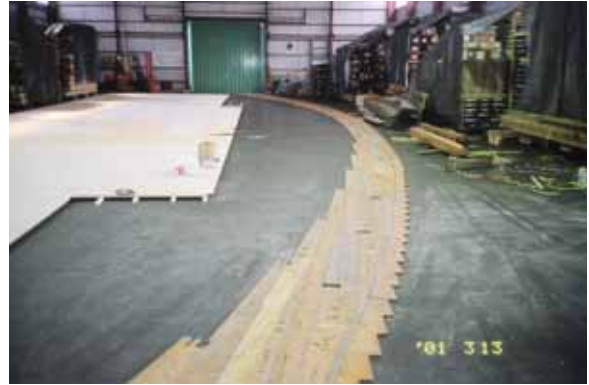
Photo 14: Template Produced in 1929 (For Reference)

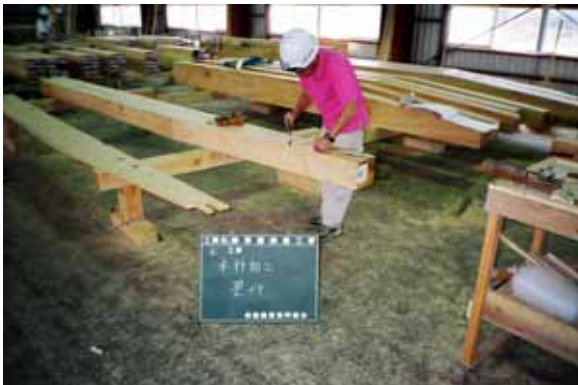
Photo 16: Marking on Timbers

After template production, each timber intended for a girder beam, marked with an appropriate template applied to the timber, is cut and machined to produce a girder beam (Photo 16).

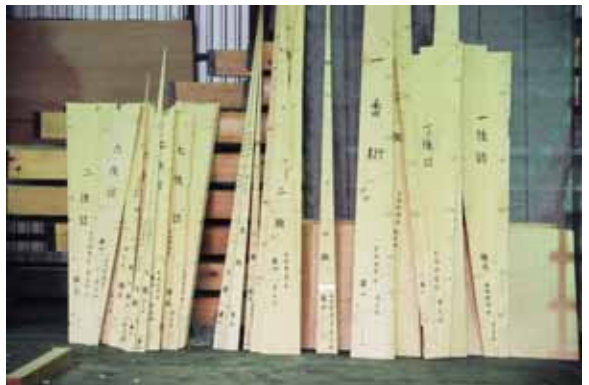
Photo 15: Templates Produced for Heisei Era Renovation

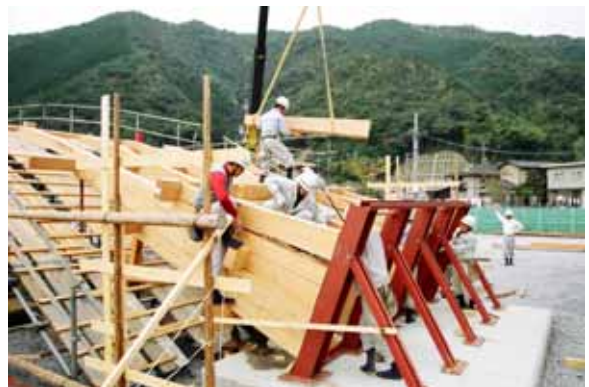
Photo 17: Bridge Girder Assembled on Land

Upon completion of timber-working, a bridge girder is temporarily assembled on land. Temporary assembly on land was also conducted before construction of the original bridge, as well as before each subsequent renewal project. The objective is to make fine adjustments to the assembly, so as to facilitate and expedite site work (Photo 17).

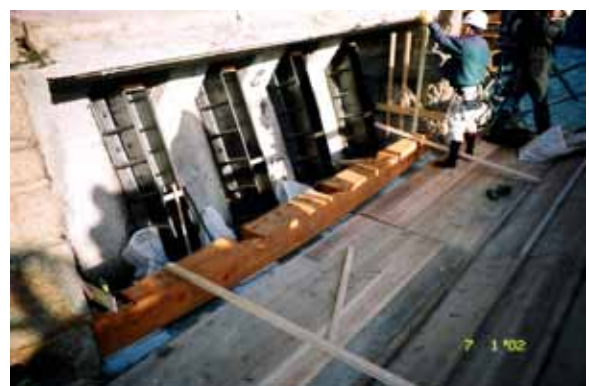
Photo 18: Installed Crossbeams

Crossbeams that support the girder are installed (Photo 18); the 1st girder member is then mounted thereon at the angle of inclination shown in the ancient drawing (Photo 19). The 1st through 4th girder members are then inserted into the iron shoe and clamped with bolts (Photo 20). The 5th through 9th girder members are stagger-mounted so that each girder member protrudes forward from the girder member immediately beneath it. After installation of the 9th girder members from both ends, a large ridge board is mounted between the two 9th girder members, to connect the trains of girder members approaching from both ends. The 10th girder members

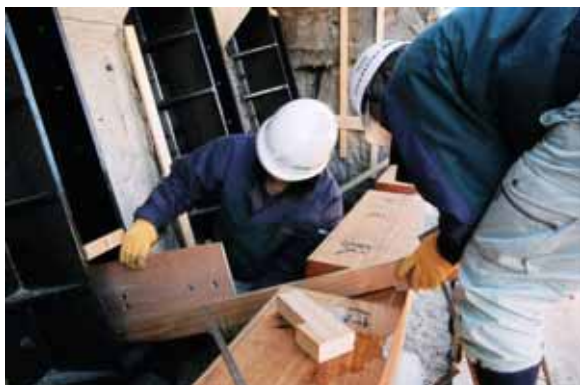
Photo 19: Angle Adjustment of 1st Girder Beam

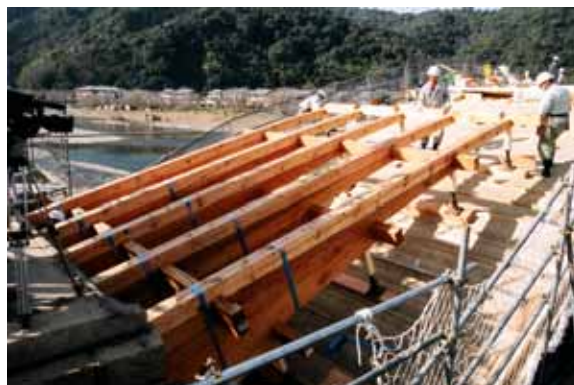
Photo 20: 1st through 4th Girder Members Fixed to Iron Shoe

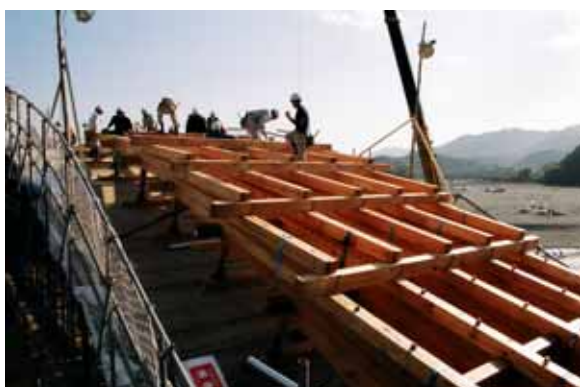
Photo 21: Bridge Girder Assembled on Site

are then mounted. After a small ridge board is installed between the 10th girder members, the 11th girder member is mounted. The girder members thus mounted are bound together using girder binders. Finally, post-packing is applied, and averaging wood members are installed to complete the girder assembly.

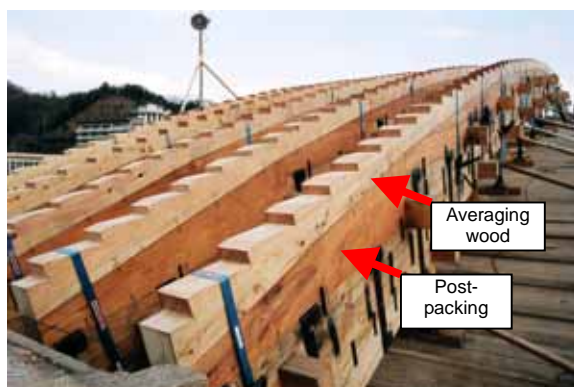
Photo 22: Post-Packing and Averaging Wood Members Installed on Girder Assembly

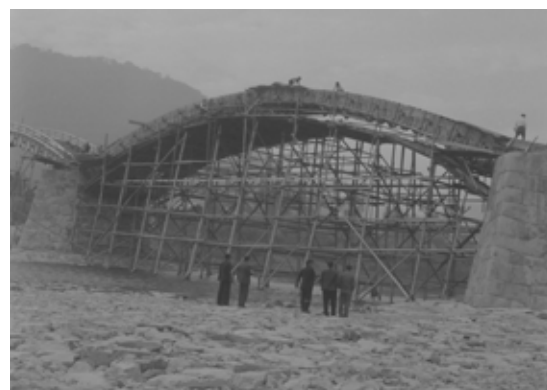
Photo 23: Rebuilding the Bridge during the Showa Period (1926 - 1989) (for reference)

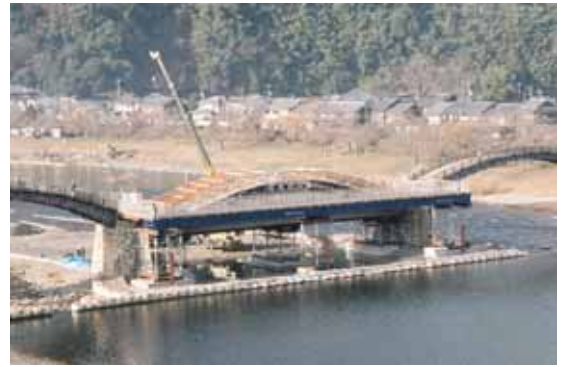
Photo 24: Alternative bridge installed during the first phase of the project

During the Heisei Period, rebuilding was carried out to construct the fourth Kintaikyo (present bridge). Because of restrictions on the project period, which is limited to the dry season, as well as other restrictions relating to procedures for gaining governmental permission, the project was implemented in three phases, which spanned three years. Since the Kintaikyo Bridge is an essential tourist resource for Iwakuni, the long duration of the project period had serious negative impact on the tourist industry. To mitigate the anticipated loss, it was decided that an alternative bridge would be built, from which tourists and local people would be able to view the rebuilding process (Photo 24).
